ADDITIONAL INFORMATION REQUIRED FOR

THE
ANACONDA COPPER COMPANY'S
JACKPILE-PAGUATE
RECLAMATION PLAN
October 27, 1980

Re: Letter - R. D. Lynn, Anaconda Copper Co.,
October 28, 1980

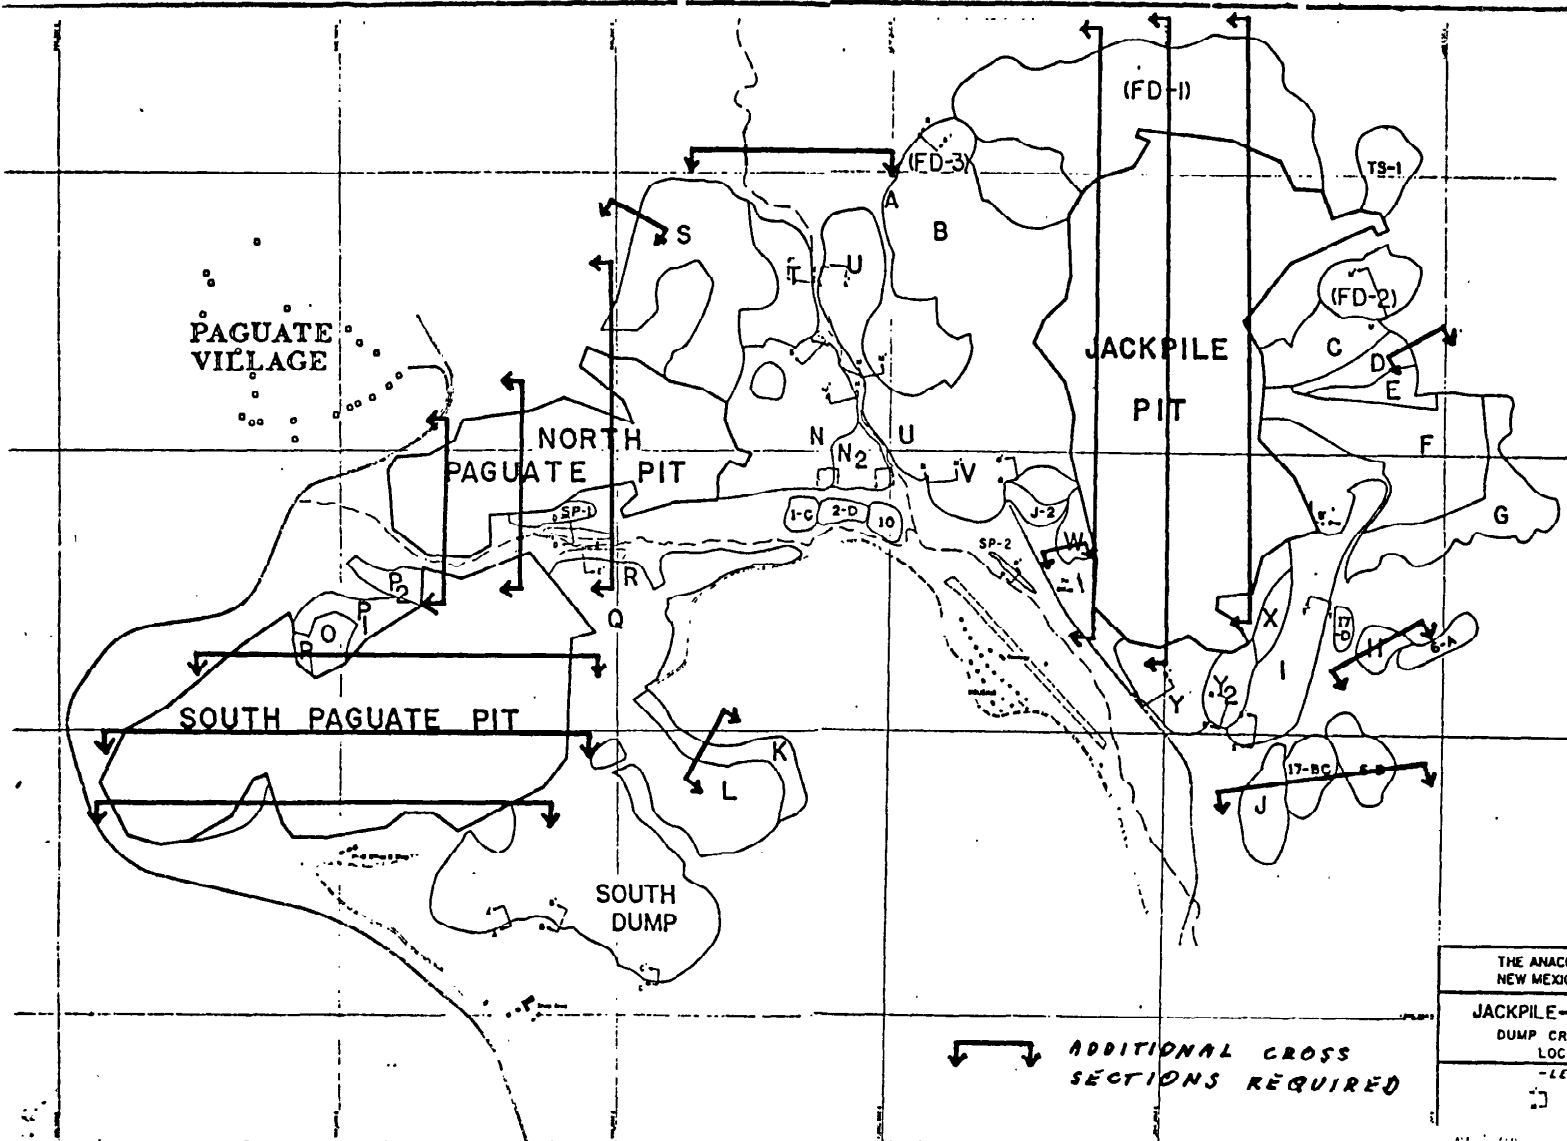
JACKPILE-PIT
DUMP CROSS
SECTION
- LCG

1. To adequately assess the final reclaimed land forms, additional detail must be provided. Please submit the cross-sections shown in red on the attached map.
